RECOMMENDED SERVICE BULLETIN

RSB D4-084

Installation of a stiffener on the alternator cable.

Installation of an Alternator Cable Stiffener

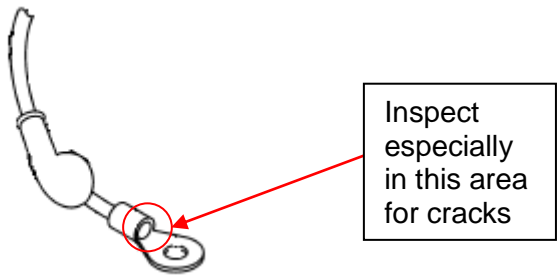
Figure 1

<p style="border: 1px solid black; padding: 5px; display: inline-block;">Inspect especially in this area for cracks</p> </div>
