MANDATORY SERVICE BULLETIN

NO. MSB-42-030/2

Check of return fuel line installation on Common Rail of TAE-Engine and replacement of Common Rail Banjo.

WI-MSB-42-030

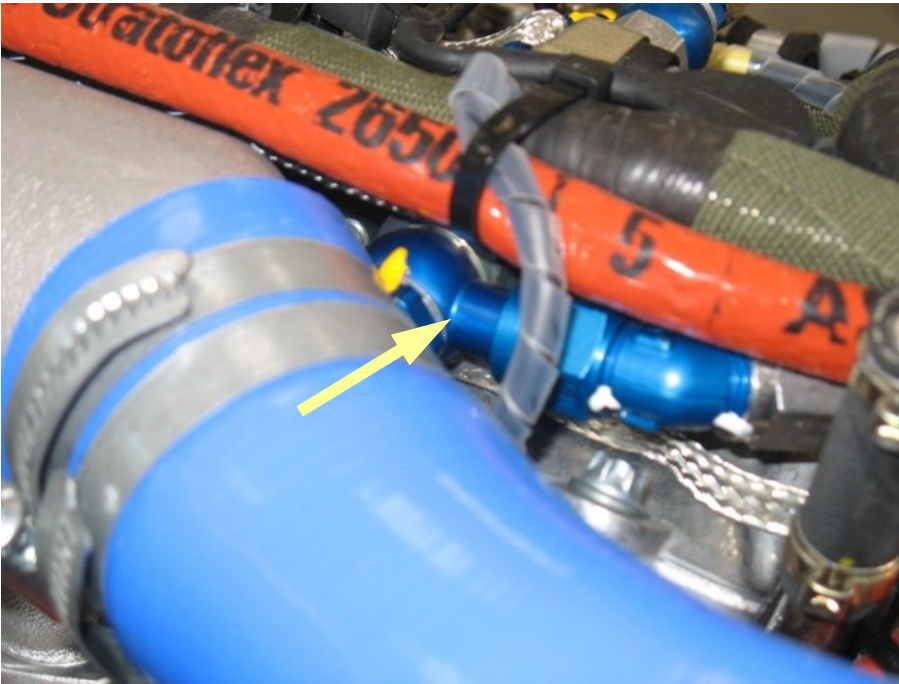
In some cases leakage occurred on the common rail banjo, where the return fuel line is connected to the common rail.

1	Remove upper cowling on LH engine according to AMM (refer to section 71-10)
2	Remove Common Rail according to Thielert Repair Manual RM-02-01, latest revision.
3	<p>Replace banjo, banjo bolt and gaskets on common rail according to Thielert Repair Manual RM-02-01, latest revision.</p>

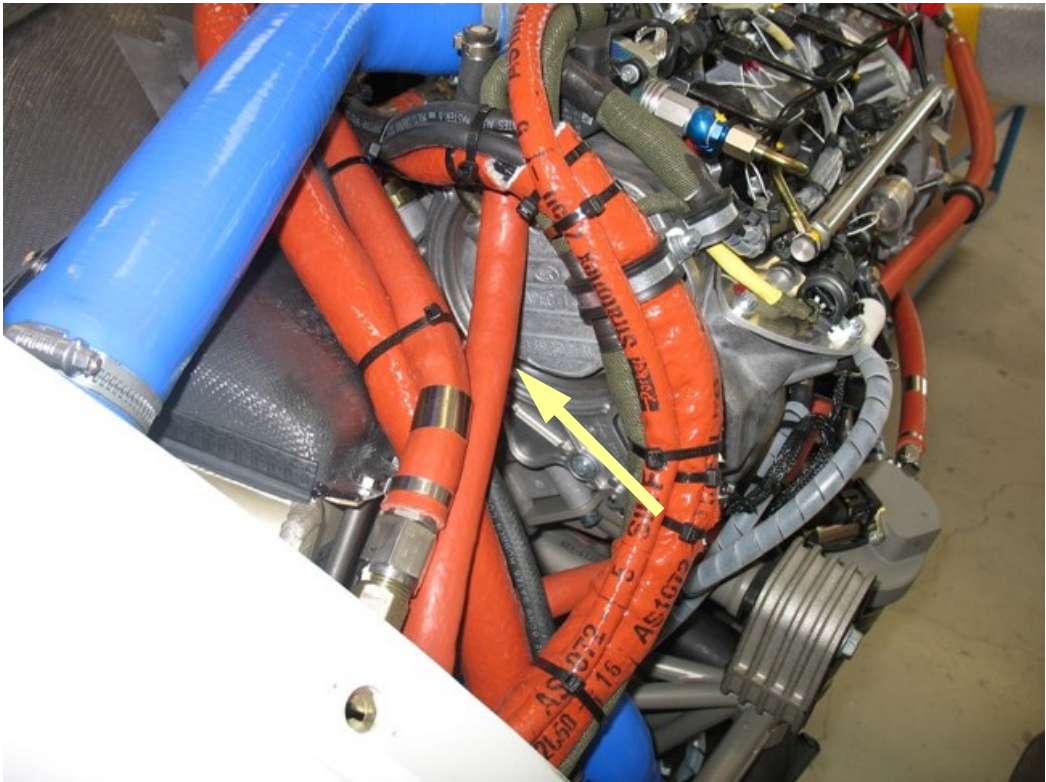
5	Install return fuel line and check for clearance between the 45° fitting downstream of the banjo and the engine housing.
6	<p>Check installation of return fuel line between connection on common rail of TAE-Engine and connection to Nacelle (fire wall):</p> <p>Return Fuel Line must not be attached with tie wrap.</p>

7	If fuel return line is attached with tie wrap, cut and remove tie wrap.
8	Clean working area and check for foreign objects.
9	Perform items 1 to 8 for RH side.
10	Perform engine ground run and check fuel hose connections for leakages.
11	Make appropriate entries into aircraft log.
