MANDATORY SERVICE BULLETIN

MSB 42-077

MSB 42NG-007

Check of emergency exit lever.

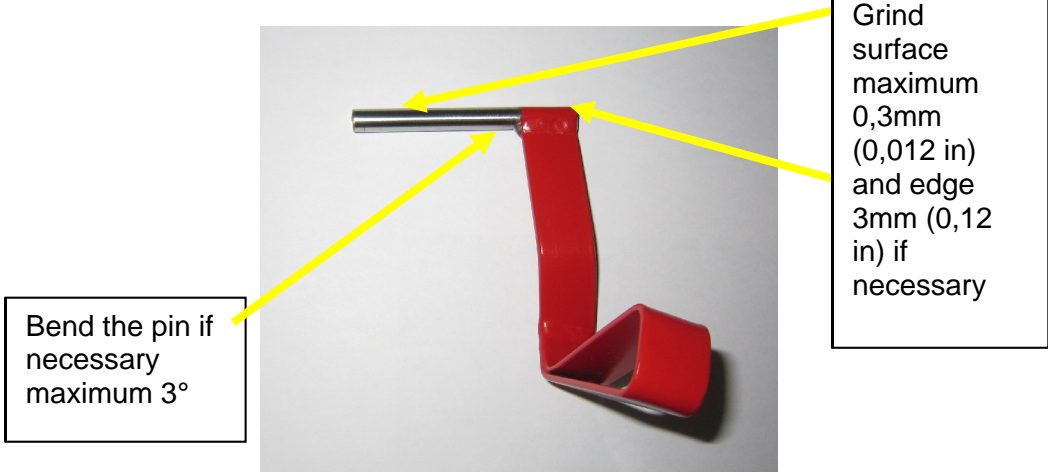
During maintenance action on some airplanes it was found that the emergency exit lever was sitting so tight that smooth operation of the door release was not guaranteed. In order to ensure an instant and smooth door release on every aircraft possibly affected a check of emergency release and corrective actions if required are prescribed on these aircraft.

5	<p>Rework lever pin, refer to picture.</p>

<p>Bend the pin if necessary maximum 3°</p> <p>Grind surface maximum 0,3mm (0,012 in) and edge 3mm (0,12 in) if necessary</p> <p>The minimum pin diameter is 5,7mm (0.225 in).</p>
6	<p>Install the modified emergency lever and test the release with hand force. If a release is possible, reinstall the emergency exit lever.</p>
7	<p>If a release is not possible, replace the emergency exit lever with DA4-5200-71-00_1.</p>
8	<p>Seal reading light and emergency lever with Terostat IX.</p>
