MANDATORY SERVICE BULLETIN

NO. MSB 42-088/3

I.5 Subject

This Service Bulletin prescribes the inspection of the joints that connect the MLG (main landing gear) damper with the MLG trailing arm for cracks.

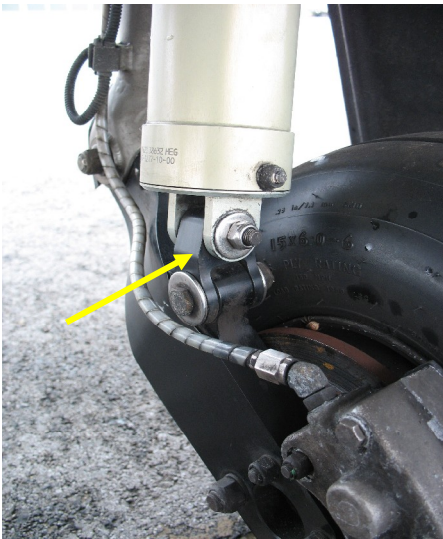
</div> <p data-bbox="794 1240 911 1272">Picture 1</p>
3	Clean the MLG joint.
4	<p>Examine the MLG joint for cracks.</p> <p>CAUTION: Look especially in the areas indicated by the arrows.</p> <div data-bbox="620 1516 1088 1859" data-label="Image">

1	Insert AMM-TR-MÄM-42-447/a & AMM-TR-MÄM-42-452 and AMM-TR-MÄM-42-368 into the AMM or use an AMM revision into which these AMM-TRs have been incorporated.
2	<p>Remove the joint P/N D60-3217-23-5x (4 different lengths available) that connects the LH MLG damper and the LH MLG trailing arm. The joint is indicated in the picture. Refer to AMM, section 32-10.</p> <div data-bbox="632 703 1077 1240" data-label="Image">

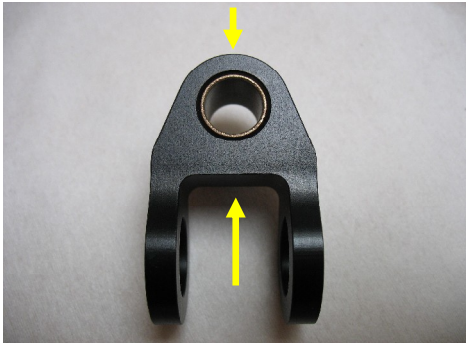
Depending on environmental, operating and runway conditions the MLG joint P/N D60-3217-23-5x (4 different lengths available) made of aluminium is susceptible to cracking. These cracks have been detected during standard maintenance, but if such cracks remain undetected, this may lead to failure of the joint and subsequent damage or malfunction of the MLG. To avoid such undetected cracks, this Service Bulletin prescribes special recurring inspection of the MLG joint.

</div> <p data-bbox="794 1859 911 1890">Picture 2</p>
5	If cracks are found, replace the MLG joint i.a.w. Section III.2. Otherwise reinstall MLG Joint.
