MANDATORY SERVICE BULLETIN

MSB 42-095

MSB 42NG-026

Replacement of MLG damper nut.

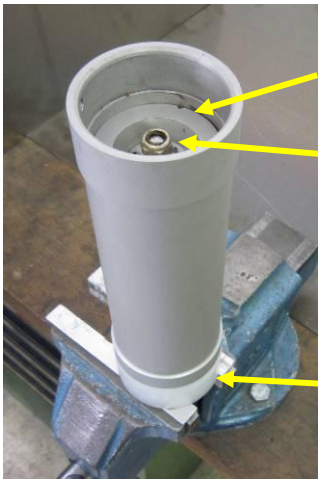
<p>Piston end plate Nut Spacer</p> <p>Picture 2</p> </div>

In one case the nut in the MLG damper has loosened itself during operation. This might lead to the MLG leg getting jammed in the gear bay. This Service Bulletin describes the work necessary to secure the nut in the MLG damper.

5	<p>Remove the bottom cap:</p> <ul style="list-style-type: none"> Remove the bolt holding the bottom cap. Pull the bottom cap from the damper assembly. <p>WARNING: Do not spill Fluid 41 on your skin or on your clothes. Fluid 41 is harmful and can cause skin disease and damage to clothes.</p> <p>Note: Catch the residual oil into a suitable container.</p> <ul style="list-style-type: none"> Clean the cap with acetone. Replace the O-Ring from the cap by new O-Ring ORAR00227-N7083 and apply a coat of Additive 1U-9891 on the new O-Ring. <p>Caution: Do not use steel tools when removing the O-Ring. Do not scratch the surfaces of the groove.</p>
6	Remove the nut on the piston end plate.
7	<p>Install nut LN 9348-08 on the piston end plate. Secure the connection with Loctite 262 i.a.w. drawing D60-3277-10-00_01.</p> <div style="text-align: center;">

8	Allow Loctite to cure before filling (Minimum cure time 12 hours).
9	Install the bottom cap with the bolt, washer and nut.
10	Remove the spacer from piston tube.
11	Install the charging valve with a new O-Ring MS 28775-010.
12	<p>Adjust the direction of the piston tube to the cylinder tube acc. to picture 3.</p> <p>Note: The charging valve must be aligned with the nut from the bolt holding the bottom cap.</p>
