SERVICE INFORMATION NO. SI 42-101

GARMIN Software Service Bulletin No. 0849, Revision A
ATA-Code: 34-00

SOFTWARE SERVICE BULLETIN

TO: Diamond Aircraft, Inc.
DATE: 21 January 2009
SUBJECT: G1000 System Software Version 0370.20 Update for G1000-equipped Diamond DA42 Aircraft

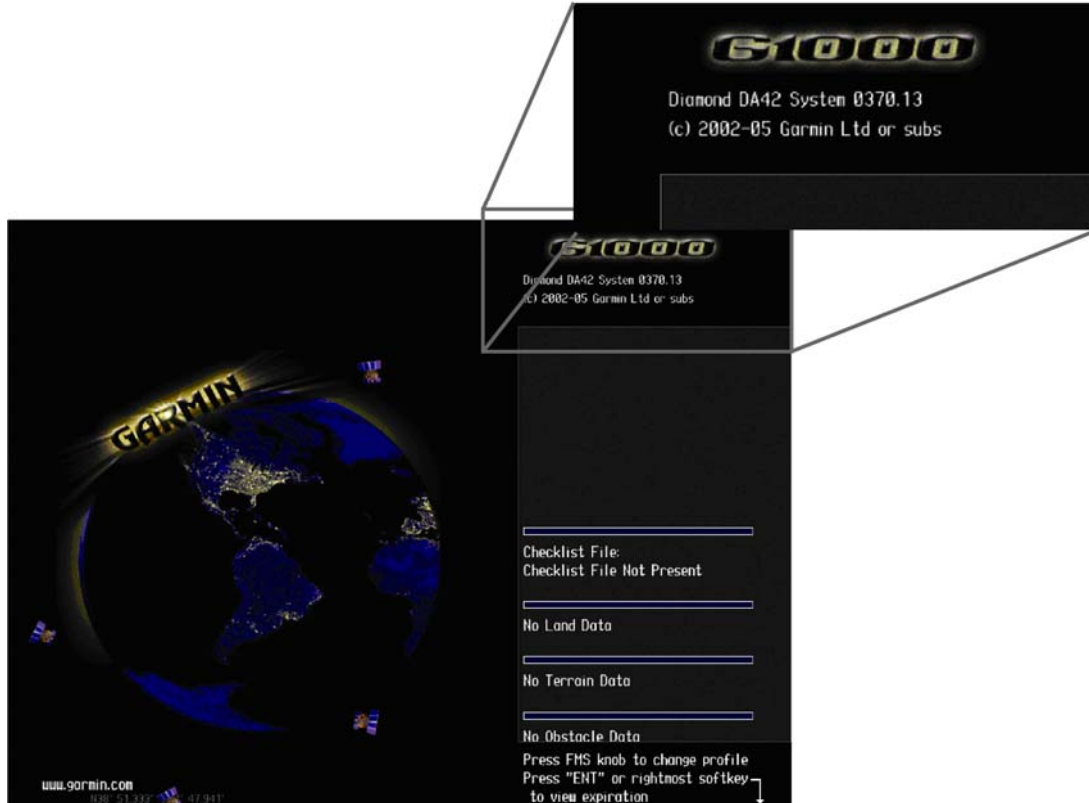
- To identify what G1000 System Software version is installed, do the steps that follow:
 1. In the aircraft, turn the aircraft MASTER switch on.
 2. Look at the MFD power-up screen (see following figure). In the upper right corner, the display shows 'Diamond DA42 System XXXX.XX'.

3. This 'System' number is the System Software Version. It correlates to the G1000 SW Loader Card used to load the software to the system. For example:

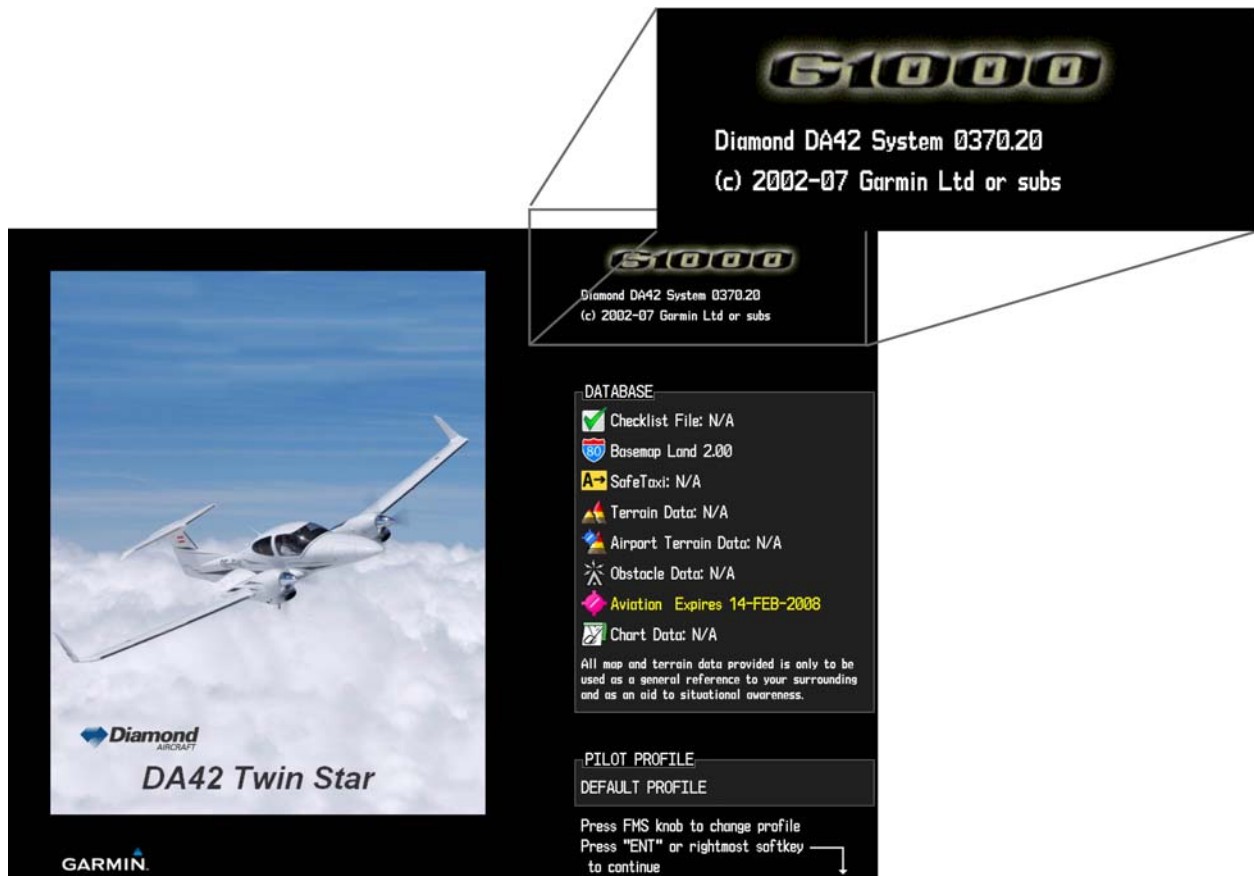
1. Look at the MFD power-up screen. In the upper right corner, the display shows 'Diamond DA42 System XXXX.XX':

2. This 'System' number is the System Software Version. It correlates to the G1000 SW Loader Card used to load the software to the system:

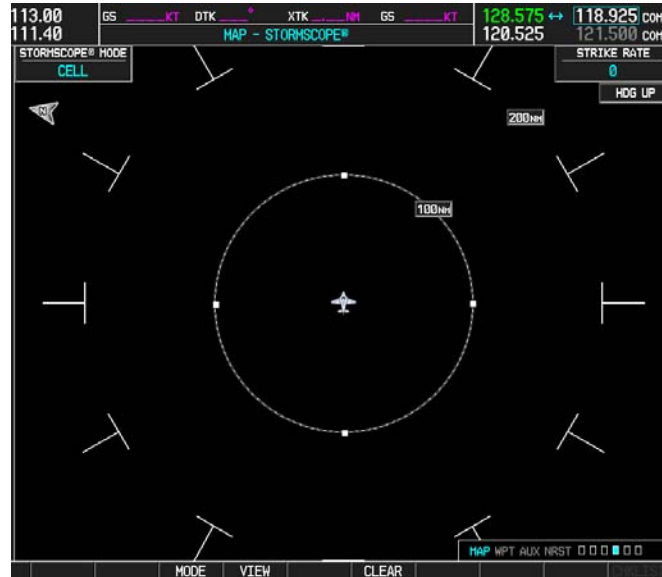
1. Using the small FMS knob, verify the Map – Stormscope page can be displayed on the MFD.
